Accessibility Assessment

Pedestrian Refuge at Baron Cameron Avenue and Village Road

Prepared by Reston Accessibility Committee (RAC)
of Reston Citizens Association
February 22, 2022

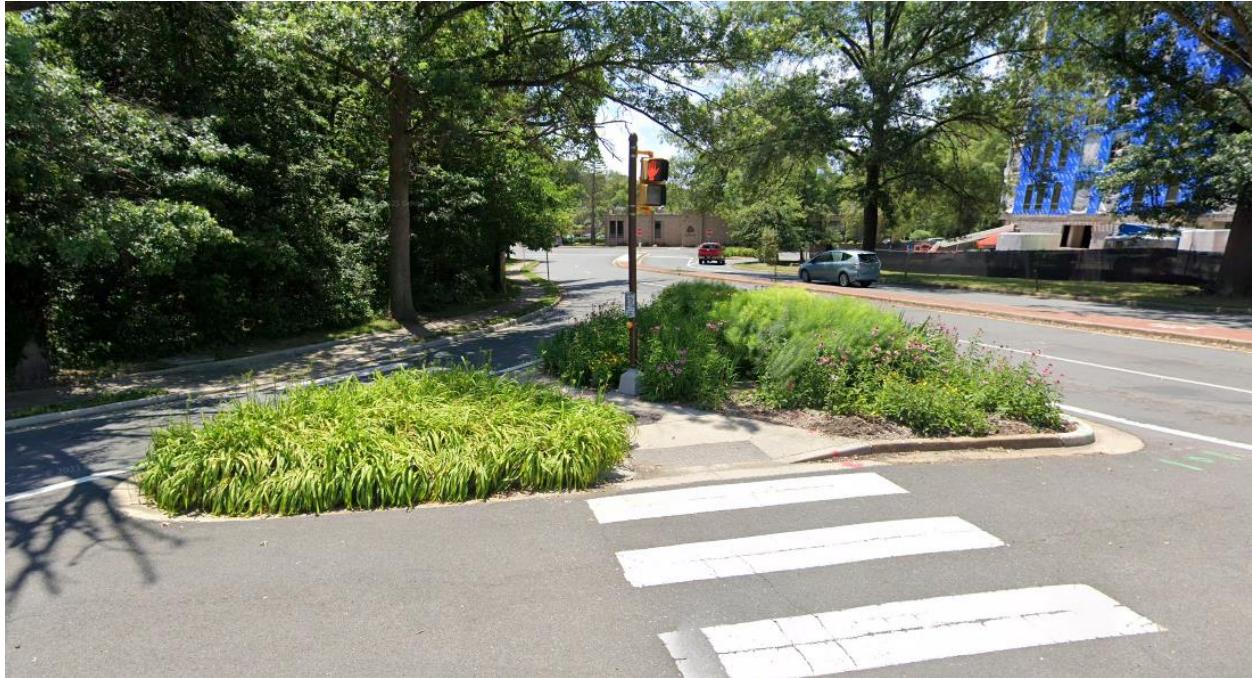
Prior to the reconstruction of the refuge, there was a sidewalk through the middle of the refuge that directly connected the two crosswalks (see Figure 1). The sidewalk had a ramp with detectable warnings at both ends.

Figure 1. Prior layout of the pedestrian refuge. (*Photo credit: Google Maps*)

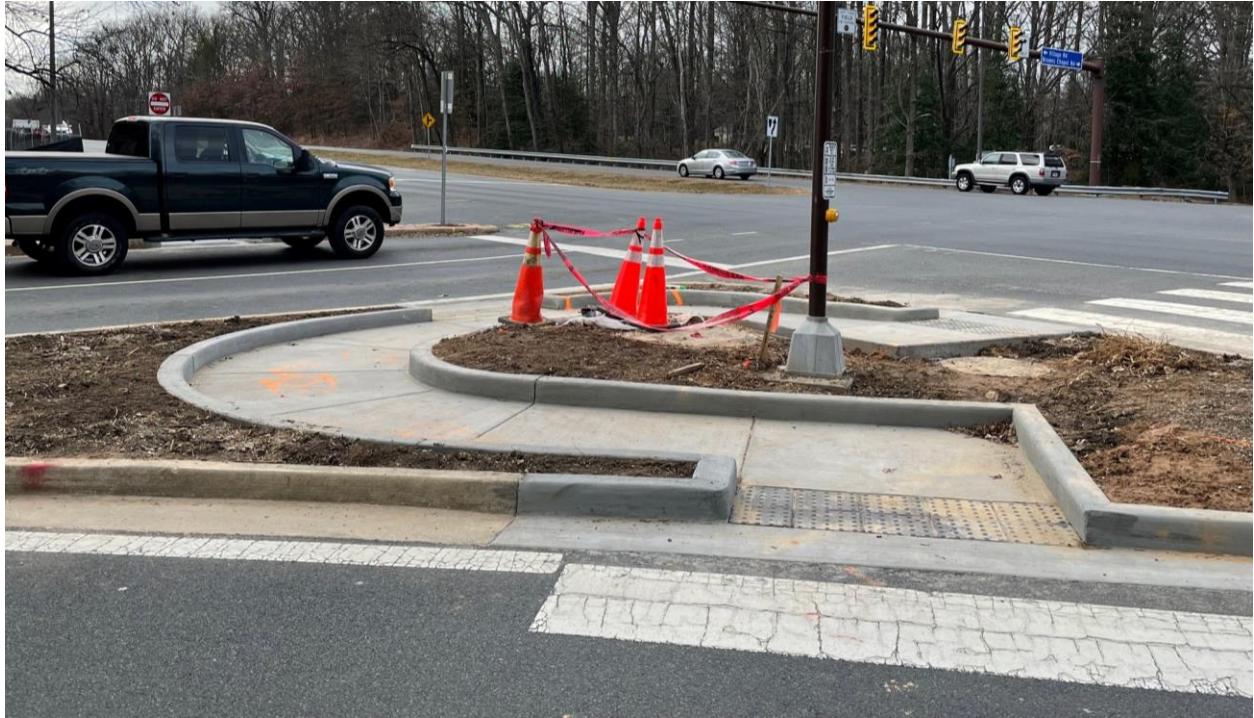
During January 2022, the refuge was reconfigured to accommodate a crossing of the straight and left-turn lanes of Village Road from the new location of the Lake Anne Fellowship House (LAFH), currently under construction. To accomplish this, the existing sidewalk on the refuge was demolished. The existing ramps were rebuilt, albeit more narrowly than before, and a new ramp was added on the west side of the refuge. Each of the ramps is five feet wide, with curbs on either edge. The three ramps are connected by a circuitous five-foot-wide sidewalk, with curbs on either side. (See Figure 2.) There is currently no crosswalk across the straight and left-turn lanes of Village Road, but one is clearly planned; a five-foot-wide cut has been added to the lane divider, allowing a straight shot to the newly-constructed ramp on the west side of Village Road, which will connect to the new LAFH site. (See Figure 3.)

Figure 2. Redesigned sidewalk along pedestrian refuge.

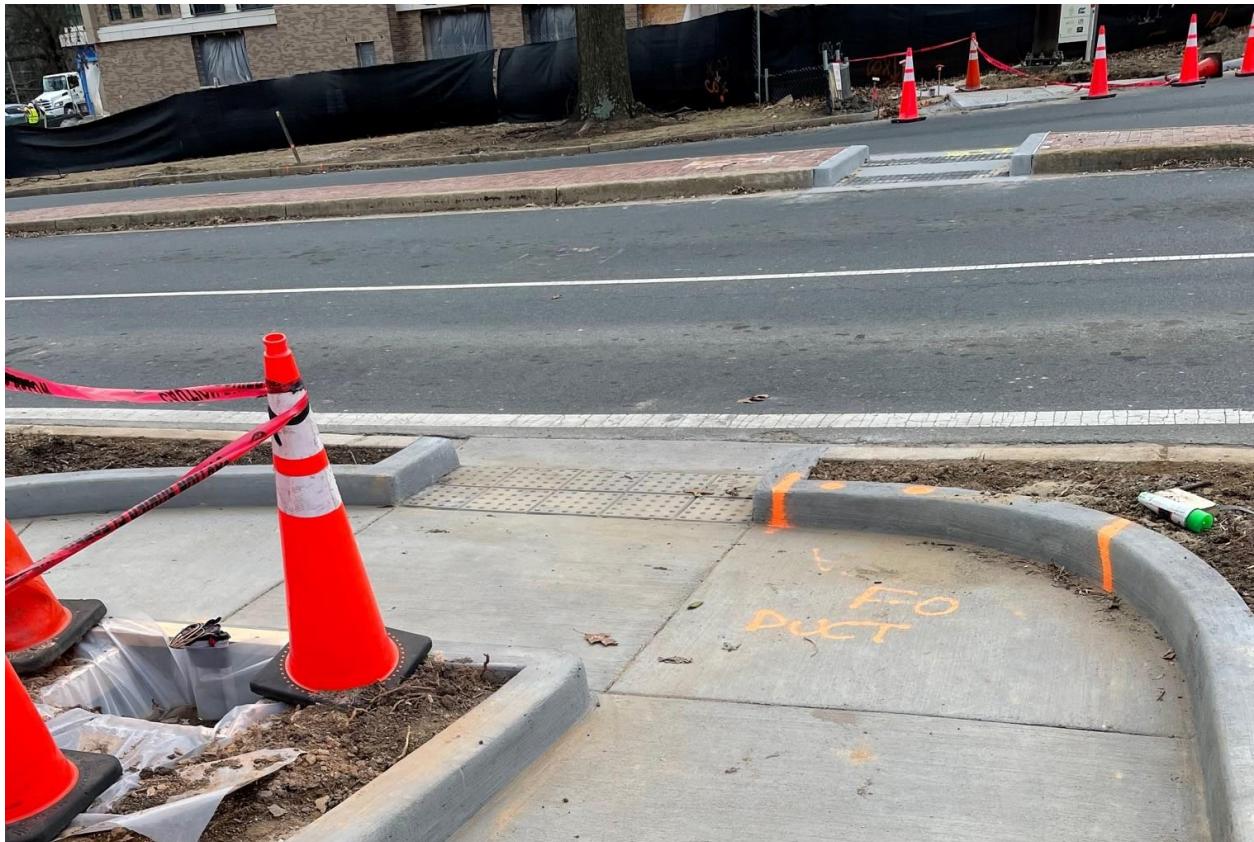
Figure 3. Planned location of crosswalk from LAFH across Village Road to the pedestrian refuge.

2. If it is not feasible to remove the slip lane, extend the pedestrian refuge toward Baron Cameron (within the approximately 15 feet of asphalt between the current edge of the refuge and the travel lanes), thus allowing the construction of a crosswalk in front of the stop line at Village Road and better designed sidewalks with proper curb ramps.

3. If the first two suggestions are not feasible, remove the crosswalk between LAFH and the refuge, and add a second crosswalk across Baron Cameron on the western side of the intersection. (This would also require a landing on the opposite side of Baron Cameron and a crosswalk at Browns Chapel Road.) LAFH residents wishing to access Lake Anne Village Center should be directed to the crosswalks at the intersection of Village Road and North Shore Drive.

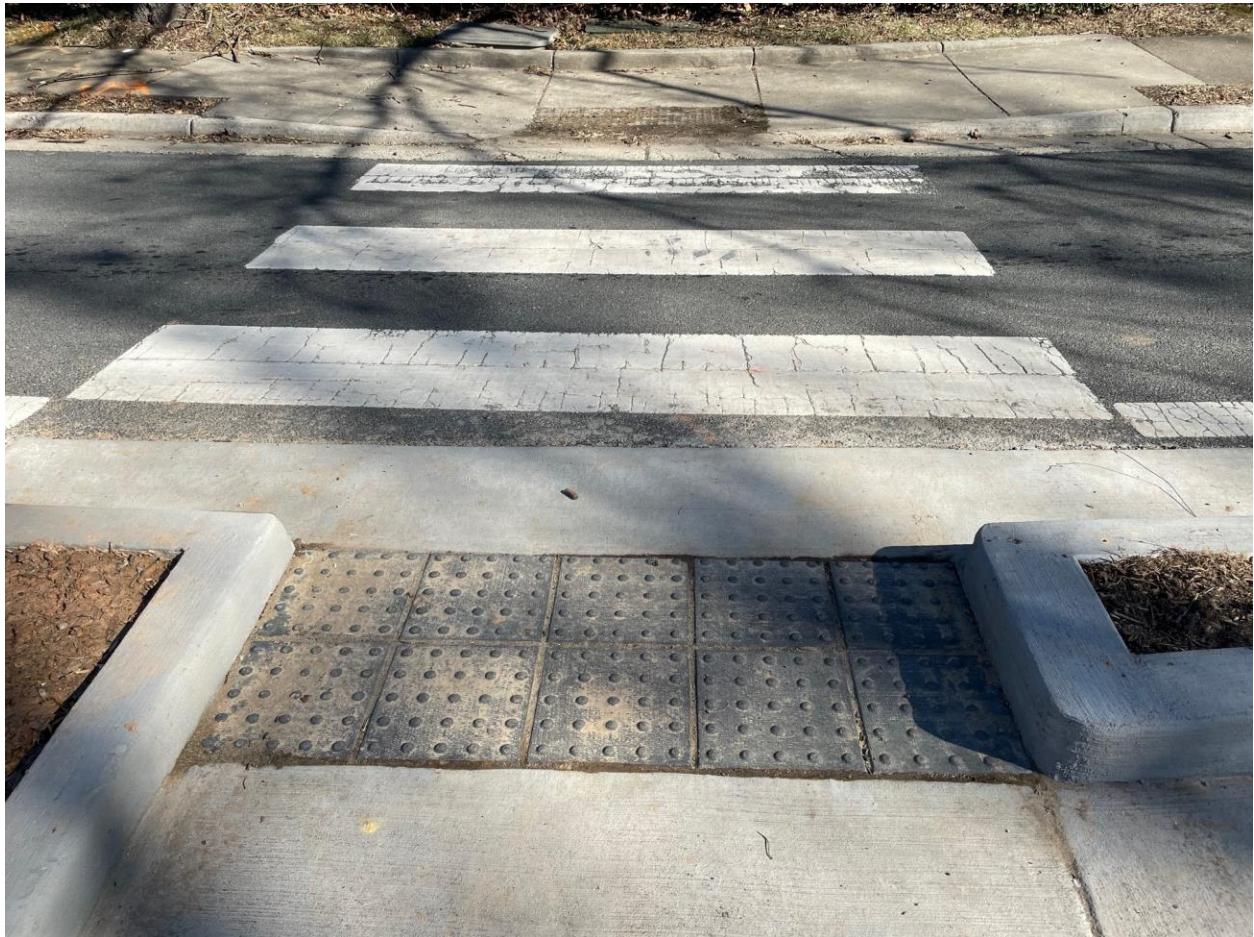
1. The ramps that connect to the crosswalks at Baron Cameron and the Village Drive right-turn lane are both considerably narrower than the crosswalks that feed into them. (See Figure 4.)

Figure 4. Crosswalk across the right-turn lane at Village Road.

2. The curbs on either side of the five-foot-wide ramp (as opposed to the typical graceful slope shown on the sidewalk in Figure 4) provide no margin for error for a person using a mobility device.

4. Widen the ramps, ideally providing sloped edges in lieu of the curbs, and provide additional turning space at either end of the sidewalk.
5. Align the Baron Cameron crosswalk with the ramp, either by restriping the crosswalk or (ideally) moving/widening the ramp.

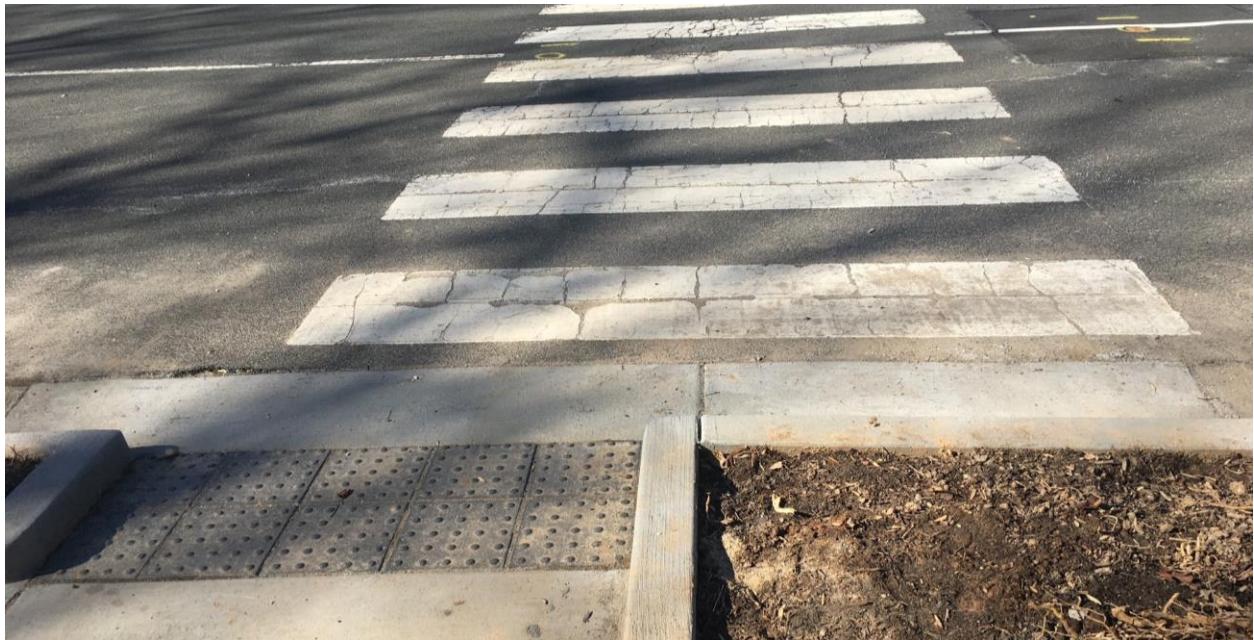
3. The ramp connecting to the Baron Cameron crosswalk is poorly aligned; there are 10 inches between the edge of the crosswalk and the curb next to the ramp (see Figure 5). There is just over 4 feet of overlap in alignment between the ramp and the crosswalk. Part of the apparent reason for this alignment is that the sidewalk ends abruptly to avoid a telephone manhole cover (see Figure 6), even though the previous sidewalk enveloped the manhole.

Figure 5. Misalignment between Baron Cameron crosswalk and ramp.

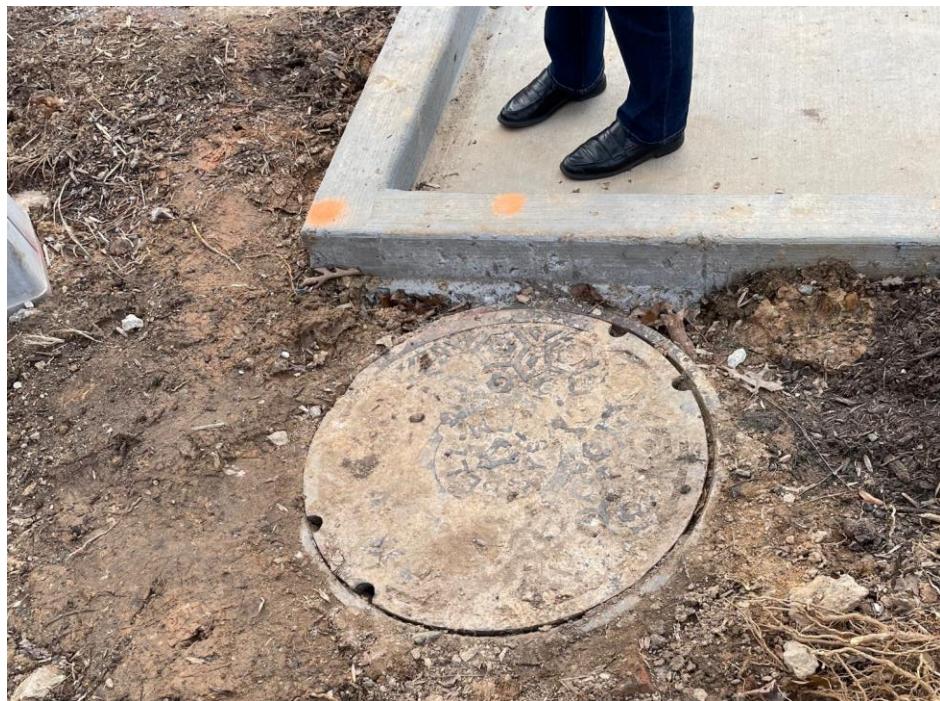
Figure 6. Manhole cover next to end of sidewalk.

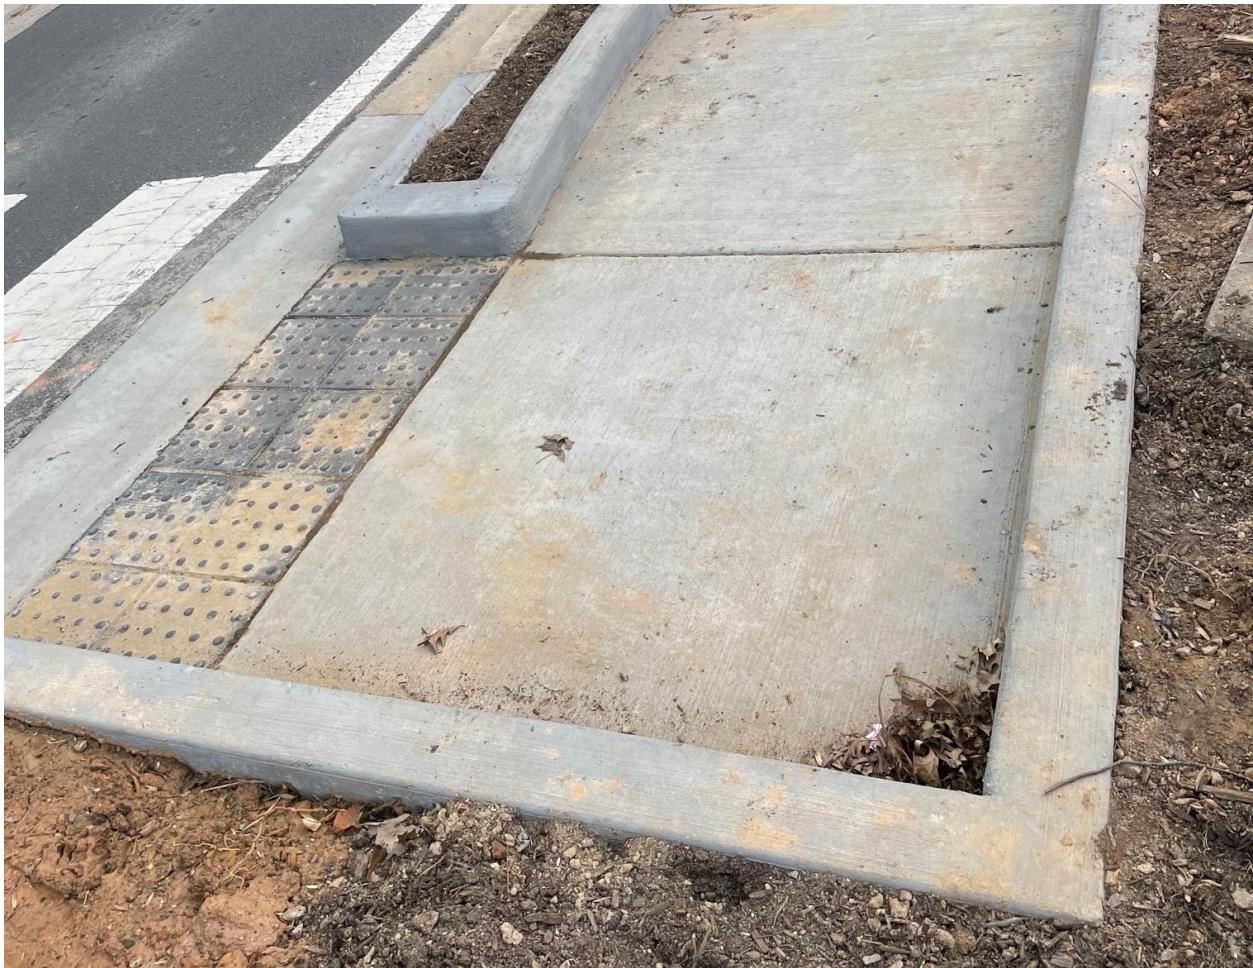
4. The layout of the sidewalk poses a serious challenge for a person using a mobility device or other wheeled vehicle (including bicycles and strollers). A person attempting to cross Baron Cameron from the east side of Village Road would need to make a 90-degree left turn immediately after reaching the refuge (see Figure 7), then wheel around to the right (including a sharp right turn after the ramp to the LAFH crosswalk; see Figure 8), and then make a 90-degree left turn at the crosswalk for Baron Cameron (see Figure 9). The sidewalk remains 5 feet wide throughout (with a slight widening to 5.5 feet after the LAFH ramp) with curbs on either side, again leaving no margin for error and creating a significant risk of collision with the curb.

Figure 7. 90-degree turn from Village Road right-turn lane.

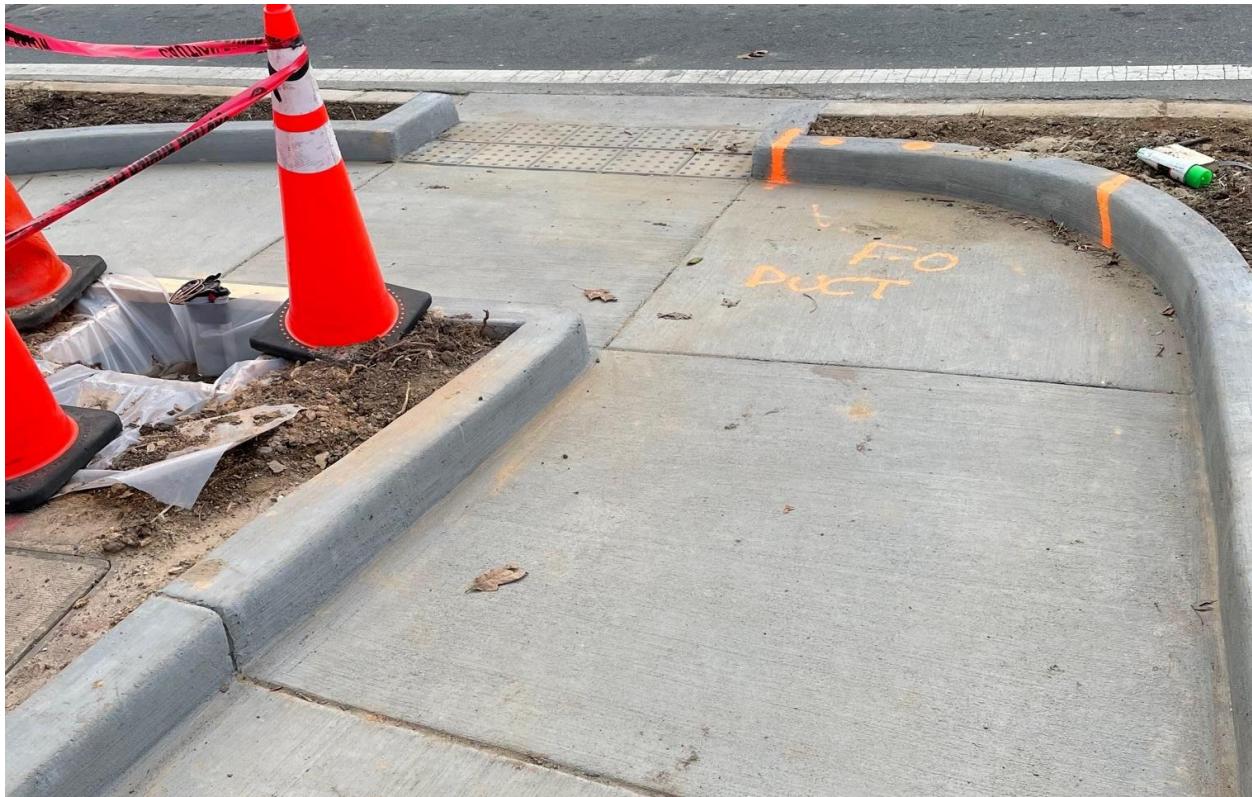
Figure 8. Sharp turn toward Baron Cameron crosswalk.

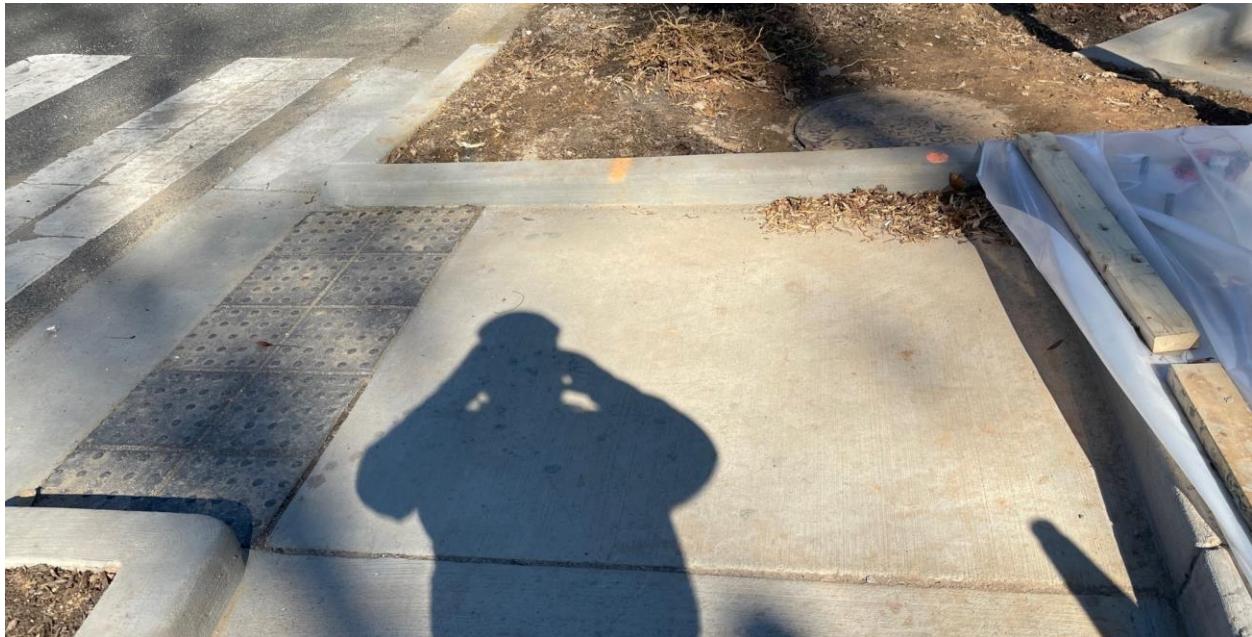
Figure 9. 90-degree turn at Baron Cameron crosswalk.

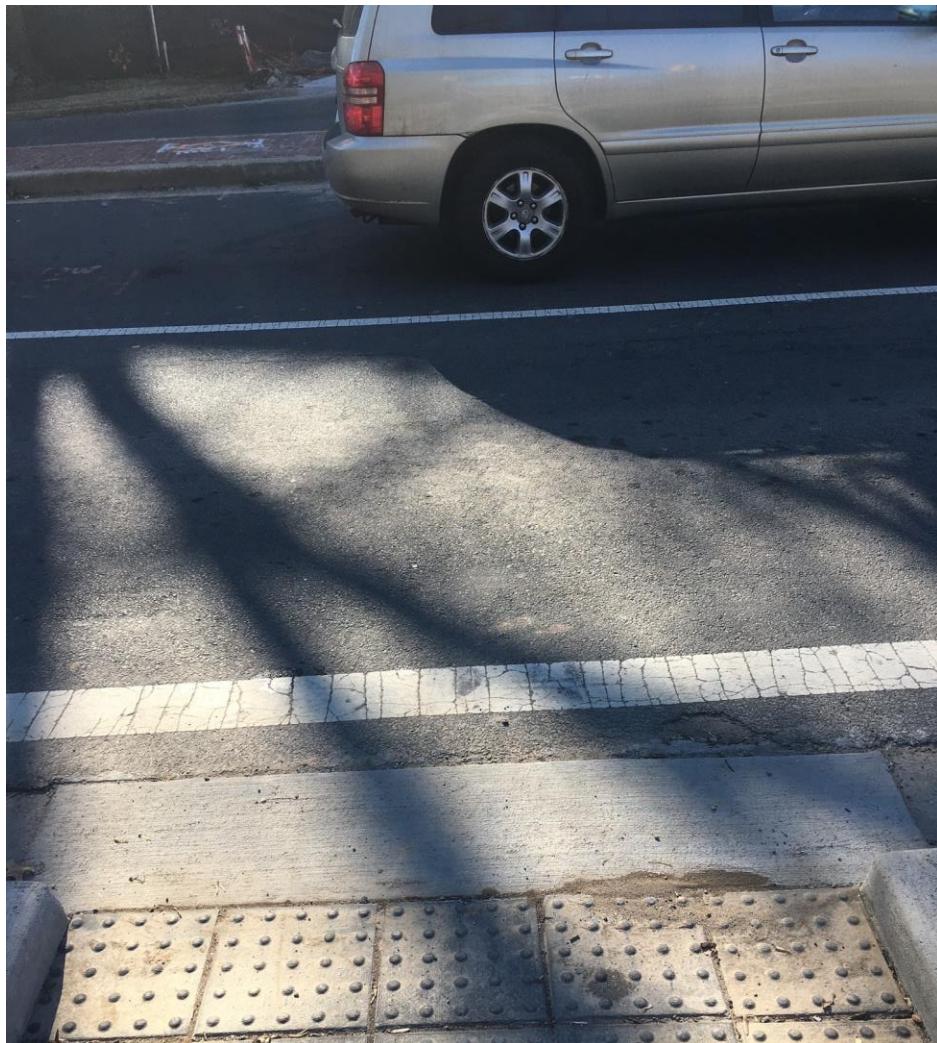
5. The planned location of the crosswalk connecting the refuge across Village Road to LAFH begins 11.5 feet behind the stop line for the traffic signal. This creates a risk of collision between pedestrians and cars pulling up to the signal; in addition, almost any

car pulling up to the stop line will block the crosswalk. (We observed this happening repeatedly during our visits to the site [see Figure 10], although in fairness, the crosswalk is not yet striped.)

Figure 10. Stopped car blocking the future Village Road crosswalk.
